Ymddiriedolaeth Addoldai Cymru
Welsh Religious Buildings Trust

Bethania, Maesteg CONSERVATION STATEMENT

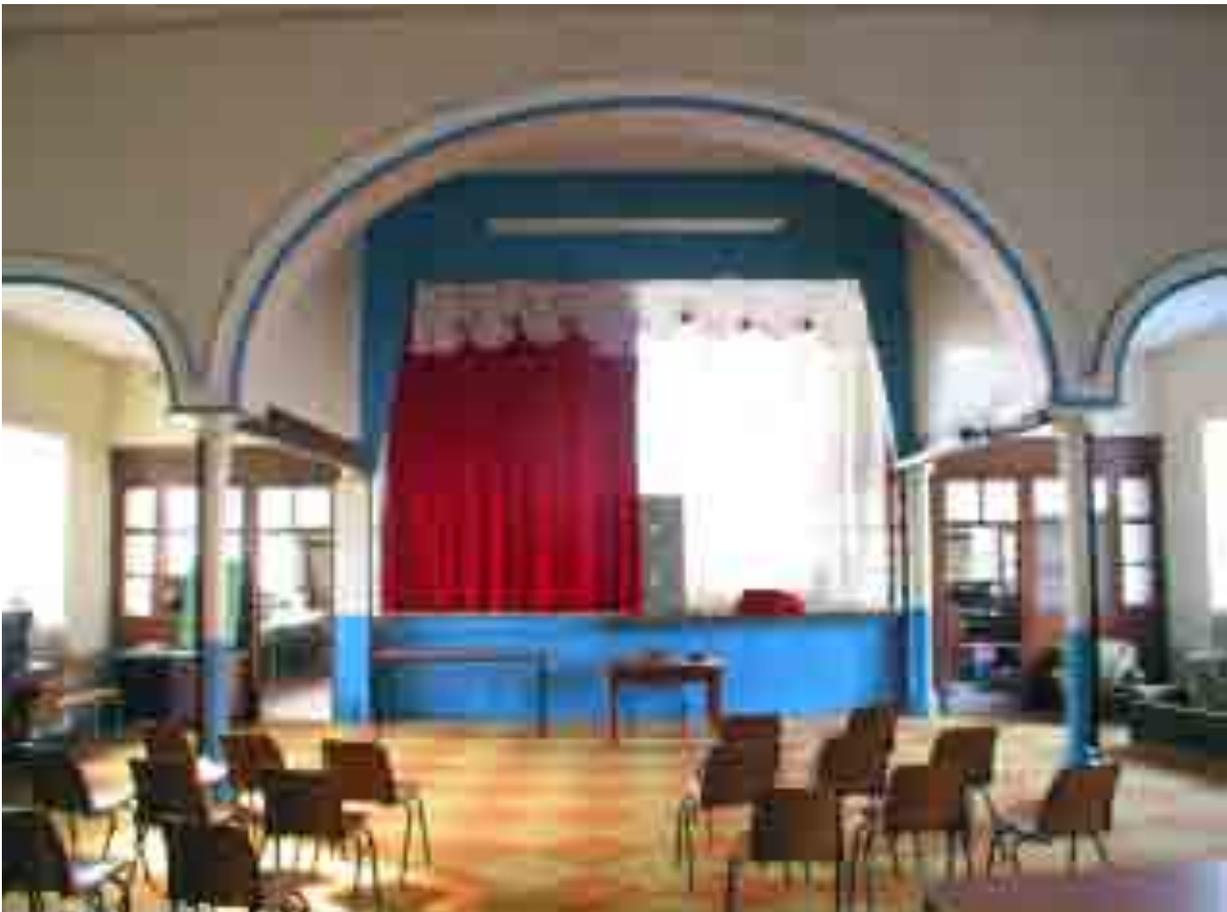
Bethania Vestry 2005 showing 1908 extension through arches, later stage

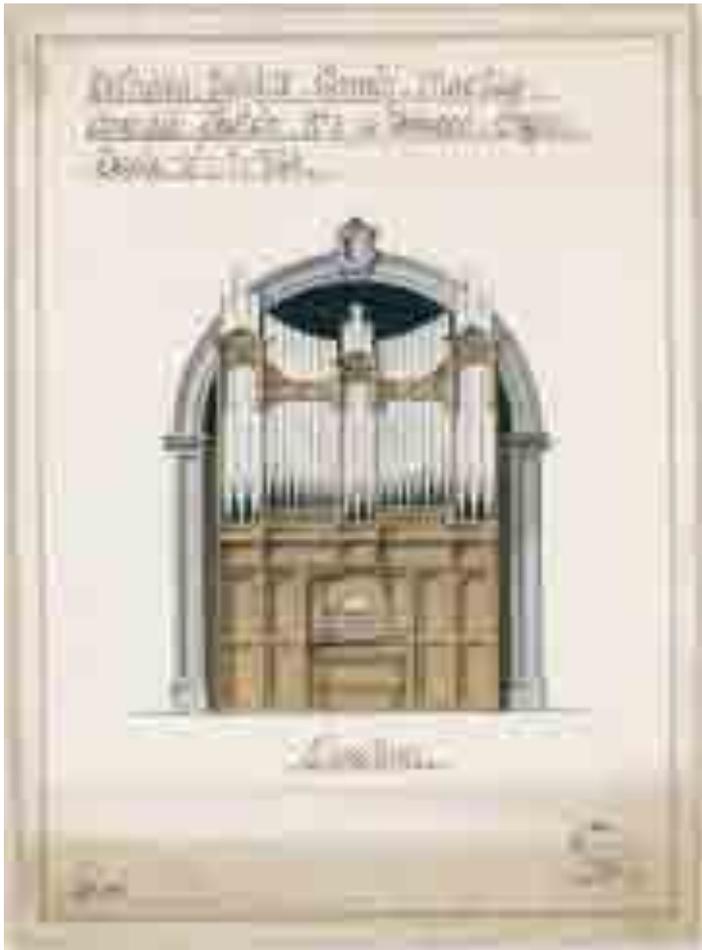
Proposed organ 1908 – JJ Binns & Co
